SUBJ: RCRA Compliance Evaluation Inspection
Benjamin Moore and Company
EPA ID Number: ALD981472798

RCRA Inspection Report

BENJAMIN MOORE AND COMPANY

COMPLIANCE EVALUATION INSPECTION PHOTOGRAPHS

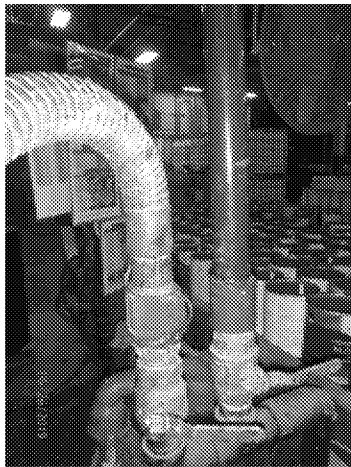
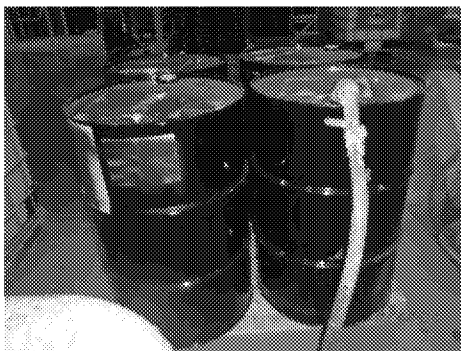
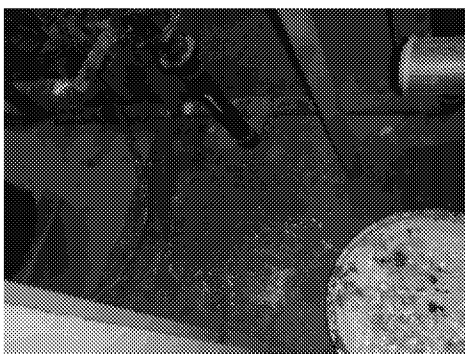
The inspectors observed that the Filling Line had four 55-gallon drums staged to capture the Alkyd fill tank flush (Picture 4). The dirty solvent flush lines were not marked (Pictures 1-3), but the lines are not currently connected to the hazardous waste tank which has been taken out of commission. Instead the dirty solvent is being piped in the 55-gallon drums. The drums were empty at the time of the inspection.

Picture [SEQ Picture * ARABIC] – Filling Line dirty solvent piping

Picture [SEQ Picture * ARABIC] – Filling Line dirty solvent hose and empty drums

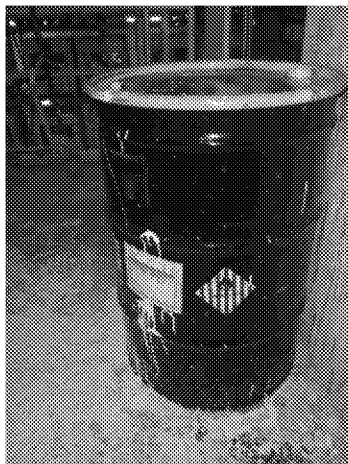
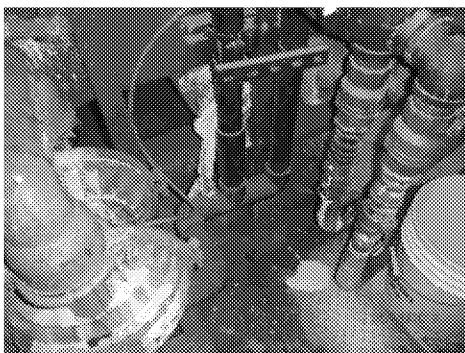
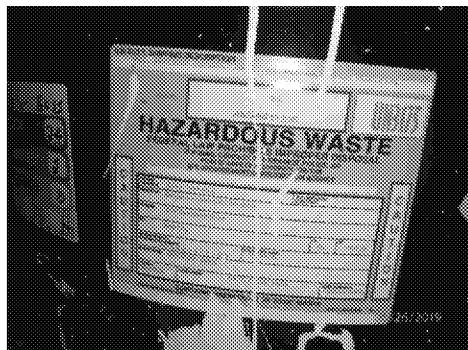
Above the Filling Line were the Fill Tower Tanks. The inspectors observed a 55-gallon satellite accumulation area (SAA) drum of hazardous waste filter bags (Pictures 5-6). The filter bags are generated from the changeover of paint formulations. The drum was closed and labeled. The inspectors also observed a 5-gallon container with a discarded hazardous waste filter bag inside (Pictures 7-8). Mr. Power explained that the 5-gallon containers are used to carry the dirty solvent filter bag to the drum and prevents releases to the area. However, the container was not labeled or closed.

Pursuant to ADEM Admin. Code r. 335-14-3-.01(5)(a)4 [40 C.F.R. § 262.15(a)(4)], which is a condition of the SAA Permit Exemption, a generator is required to keep containers of hazardous waste closed at all times during accumulation, except when adding, removing, or

Pursuant to ADEM Admin. Code r. 335-14-3-.01(5)(a)5 [40 C.F.R. § 262.15(a)(5)], which is a condition of the SAA Permit Exemption, a generator is required to mark or label its containers (i) with the words “Hazardous Waste” and (ii) with an indication of the hazards of the contents.

Picture [SEQ Picture * ARABIC] – Filling Line HW filter bag SAA

Picture [SEQ Picture * ARABIC] – Filling Line HW filter bag SAA label

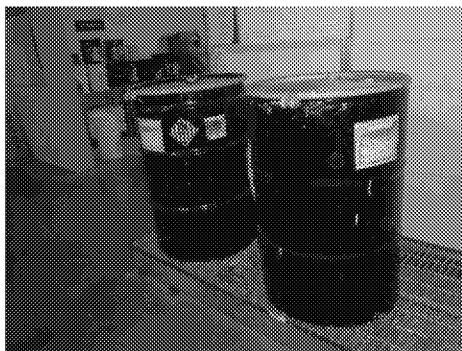
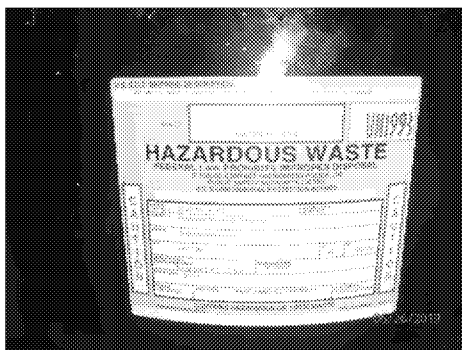
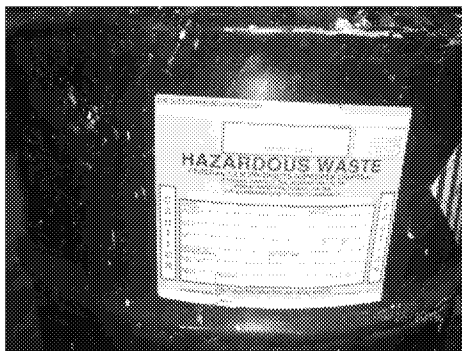
The inspectors observed the Small Batch Process, a smaller version of the main production area, that specializes in specific customer needs. The SAA contained a 55-gallon hazardous waste drum of paint filter bags and a 55-gallon hazardous waste drum of paint skins (Pictures 9-11). The drums were closed and labeled.

Picture [SEQ Picture * ARABIC] – Small Batch Process SAA

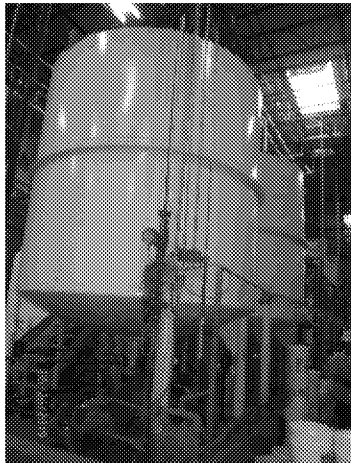
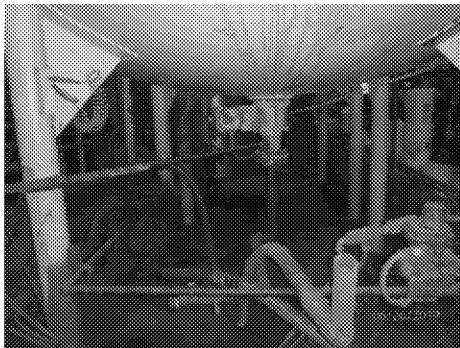
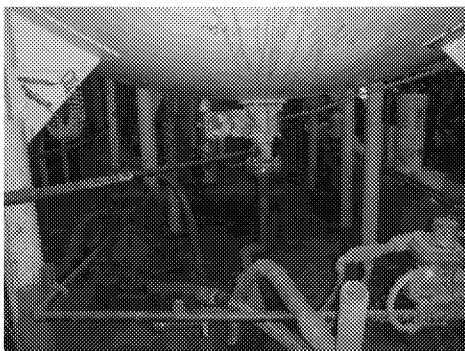
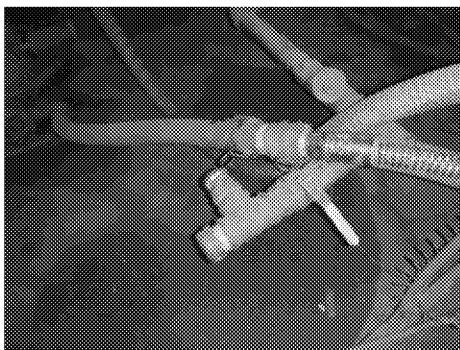
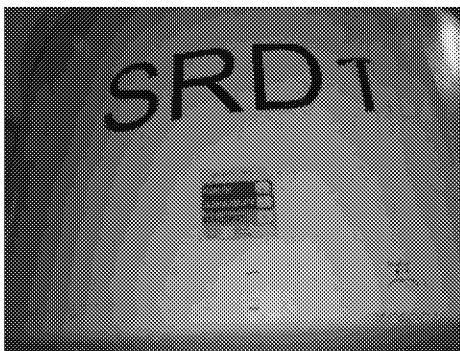
The main warehouse has final product stored in the center aisle and raw materials on the side aisles. This warehouse also houses the solvent tanks and the solvent still. The solvent recovery dirty tank, SRD1 was disconnected from all piping receiving dirty solvent (Pictures 12-16). During the December 18, 2018 RCRA inspection by ADEM, the inspector, Mr. Corey Holmes, observed that the tank and its auxiliary connections were not tagged or monitored for leak detection, daily inspections were not conducted on the tank, the tank was not labeled as hazardous waste and the tank did not have an integrity test conducted by a professional engineer.

Picture [SEQ Picture * ARABIC] – Warehouse Solvent Recovery Dirty tank

Picture [SEQ Picture * ARABIC] – Warehouse Solvent Recovery Dirty tank piping

Picture [SEQ Picture * ARABIC] – Warehouse Solvent Recovery Dirty tank label

Mr. Power and Mr. Breckenridge explained to the inspectors that the company had a tank integrity test conducted and found that it was beneficial to discontinue use and disconnect the tank based on the engineering report. A new tank has been ordered to replace the existing tank. Mr. Power assured the inspectors that the new tank will be installed according to the RCRA tank requirements and monitored as required.

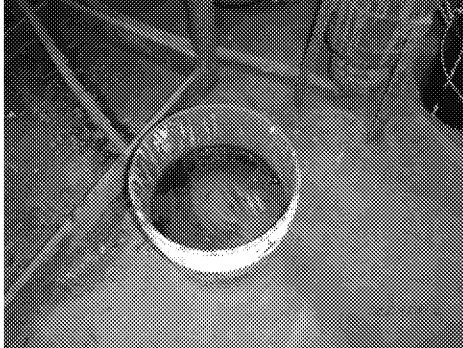
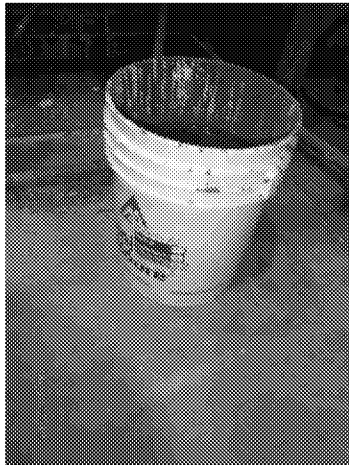
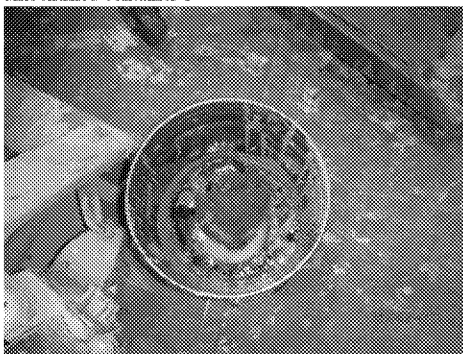
At the time of the inspection, the inspectors observed two 5-gallon containers of unidentified contents. The containers were not closed or labeled. Mr. Power and Mr. Breckenridge were not aware of the contents.

Pursuant to ADEM Admin. Code r. 335-14-3-.01(2) [40 C.F.R. § 262.11], a person who generates a solid waste, as defined in ADEM Admin. Code r. 335-14-2-.01(2) [40 C.F.R. §

Picture [SEQ Picture * ARABIC] – Distillation unidentified container 1

Picture [SEQ Picture * ARABIC] – Distillation unidentified container 2

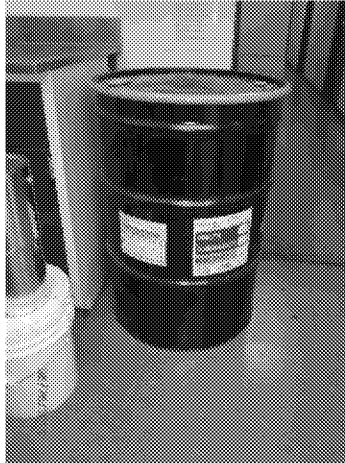
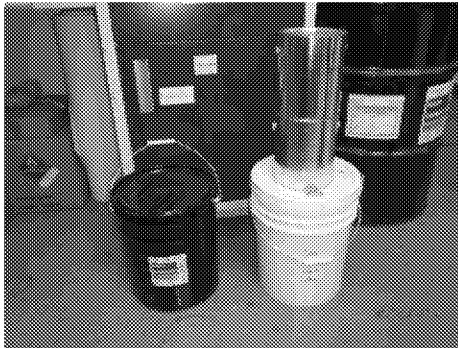
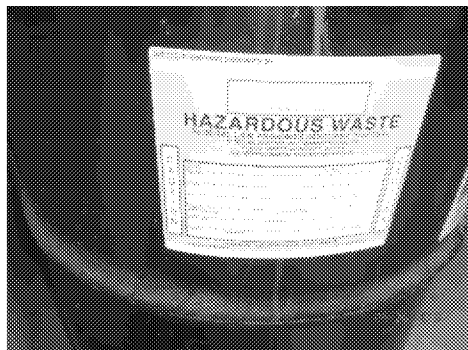
gallon container of latex waste, two silver one-gallon containers of latex waste, a black 5-gallon container of lab waste that did not have hazardous waste label (Pictures 20-22), a cart with spent aerosol cans to be punctured that were not labeled (Picture 23), and a red fire can of xylene used for cleaning paint brushes (Picture 24).

Pursuant to ADEM Admin. Code r. 335-14-3-.01(5)(a)5 [40 C.F.R. § 262.15(a)(5)], which is a condition of the SAA Permit Exemption, a generator is required to mark or label its containers (i) with the words “Hazardous Waste” and (ii) with an indication of the hazards of the contents.

Picture [SEQ Picture * ARABIC] – Low Flash Lab SAA drum

Picture [SEQ Picture * ARABIC] – Low Flash Lab SAA, non-HW containers and unidentified container

Picture [SEQ Picture * ARABIC] – Low Flash Lab
SAA drum label

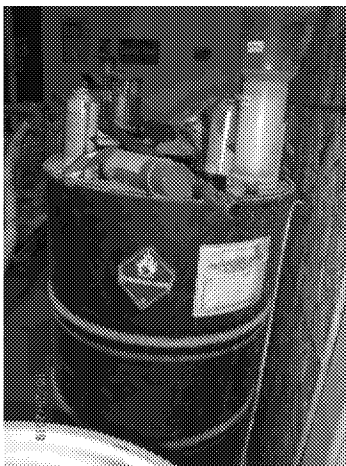
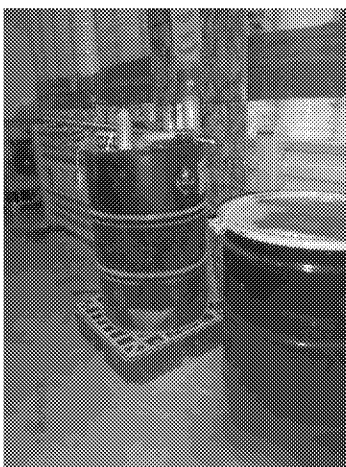
The 55-gallon SAA drum of spent aerosol residue was in the Caustic Wash area (Pictures 25-26). The drum had an aerosol can puncture system attached to the bung and aerosol cans and debris stored on top. The drum was observed closed and labeled.

Picture [SEQ Picture * ARABIC] – Caustic Wash
aerosol can puncture system and drum

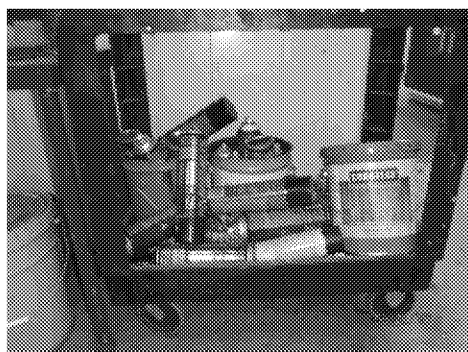
Picture [SEQ Picture * ARABIC] – Low Flash Lab
spent aerosol cans

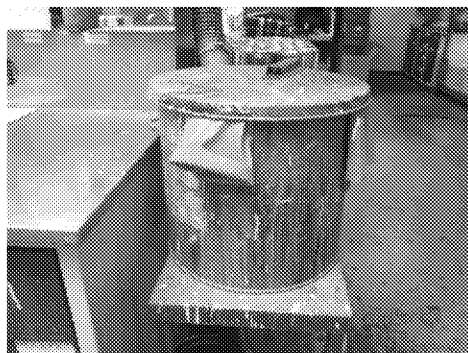
Picture [SEQ Picture * ARABIC] – Low Flash Lab
xylene cleaning container

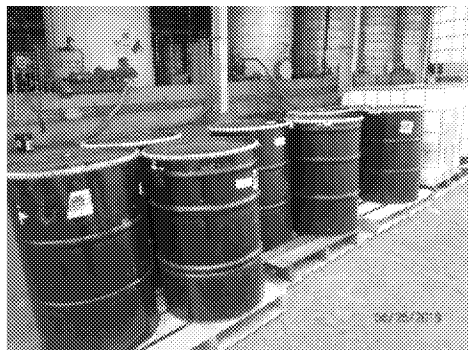
At the time of the inspection, six 55-gallon used oil drums and two 55-gallon drums of sprinkler water were staged near the tank farm waiting for pickup (Picture 27). The drums had been staged since June 25, 2019, but the transporter had not yet arrived to pump the oil out of the drums. The used oil drums are normally stored in the non-hazardous waste area of the CAA. The used oil was generated from the air compressor.

Picture [SEQ Picture * ARABIC] – Used oil drums staged

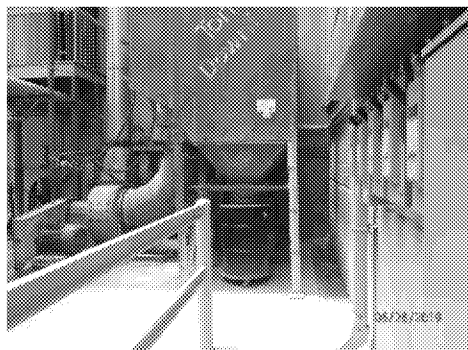
During the tour, the inspectors observed an outside baghouse. Mr. Power explained that the facility has five baghouse hoppers for pigment dust. The baghouse the inspectors observed had three hoppers with 55-gallons drums underneath (Pictures 28-29). The pigment dust is disposed of as non-hazardous waste.

Picture [SEQ Picture * ARABIC] – Pigment Dust Baghouse and drums
